# QUINHAGAK, ALASKA

## Kanektok River Erosion Study

February 2019

CRW Engineering Group, LLC  
3940 Arctic Blvd. Suite 300 Anchorage, AK 99503

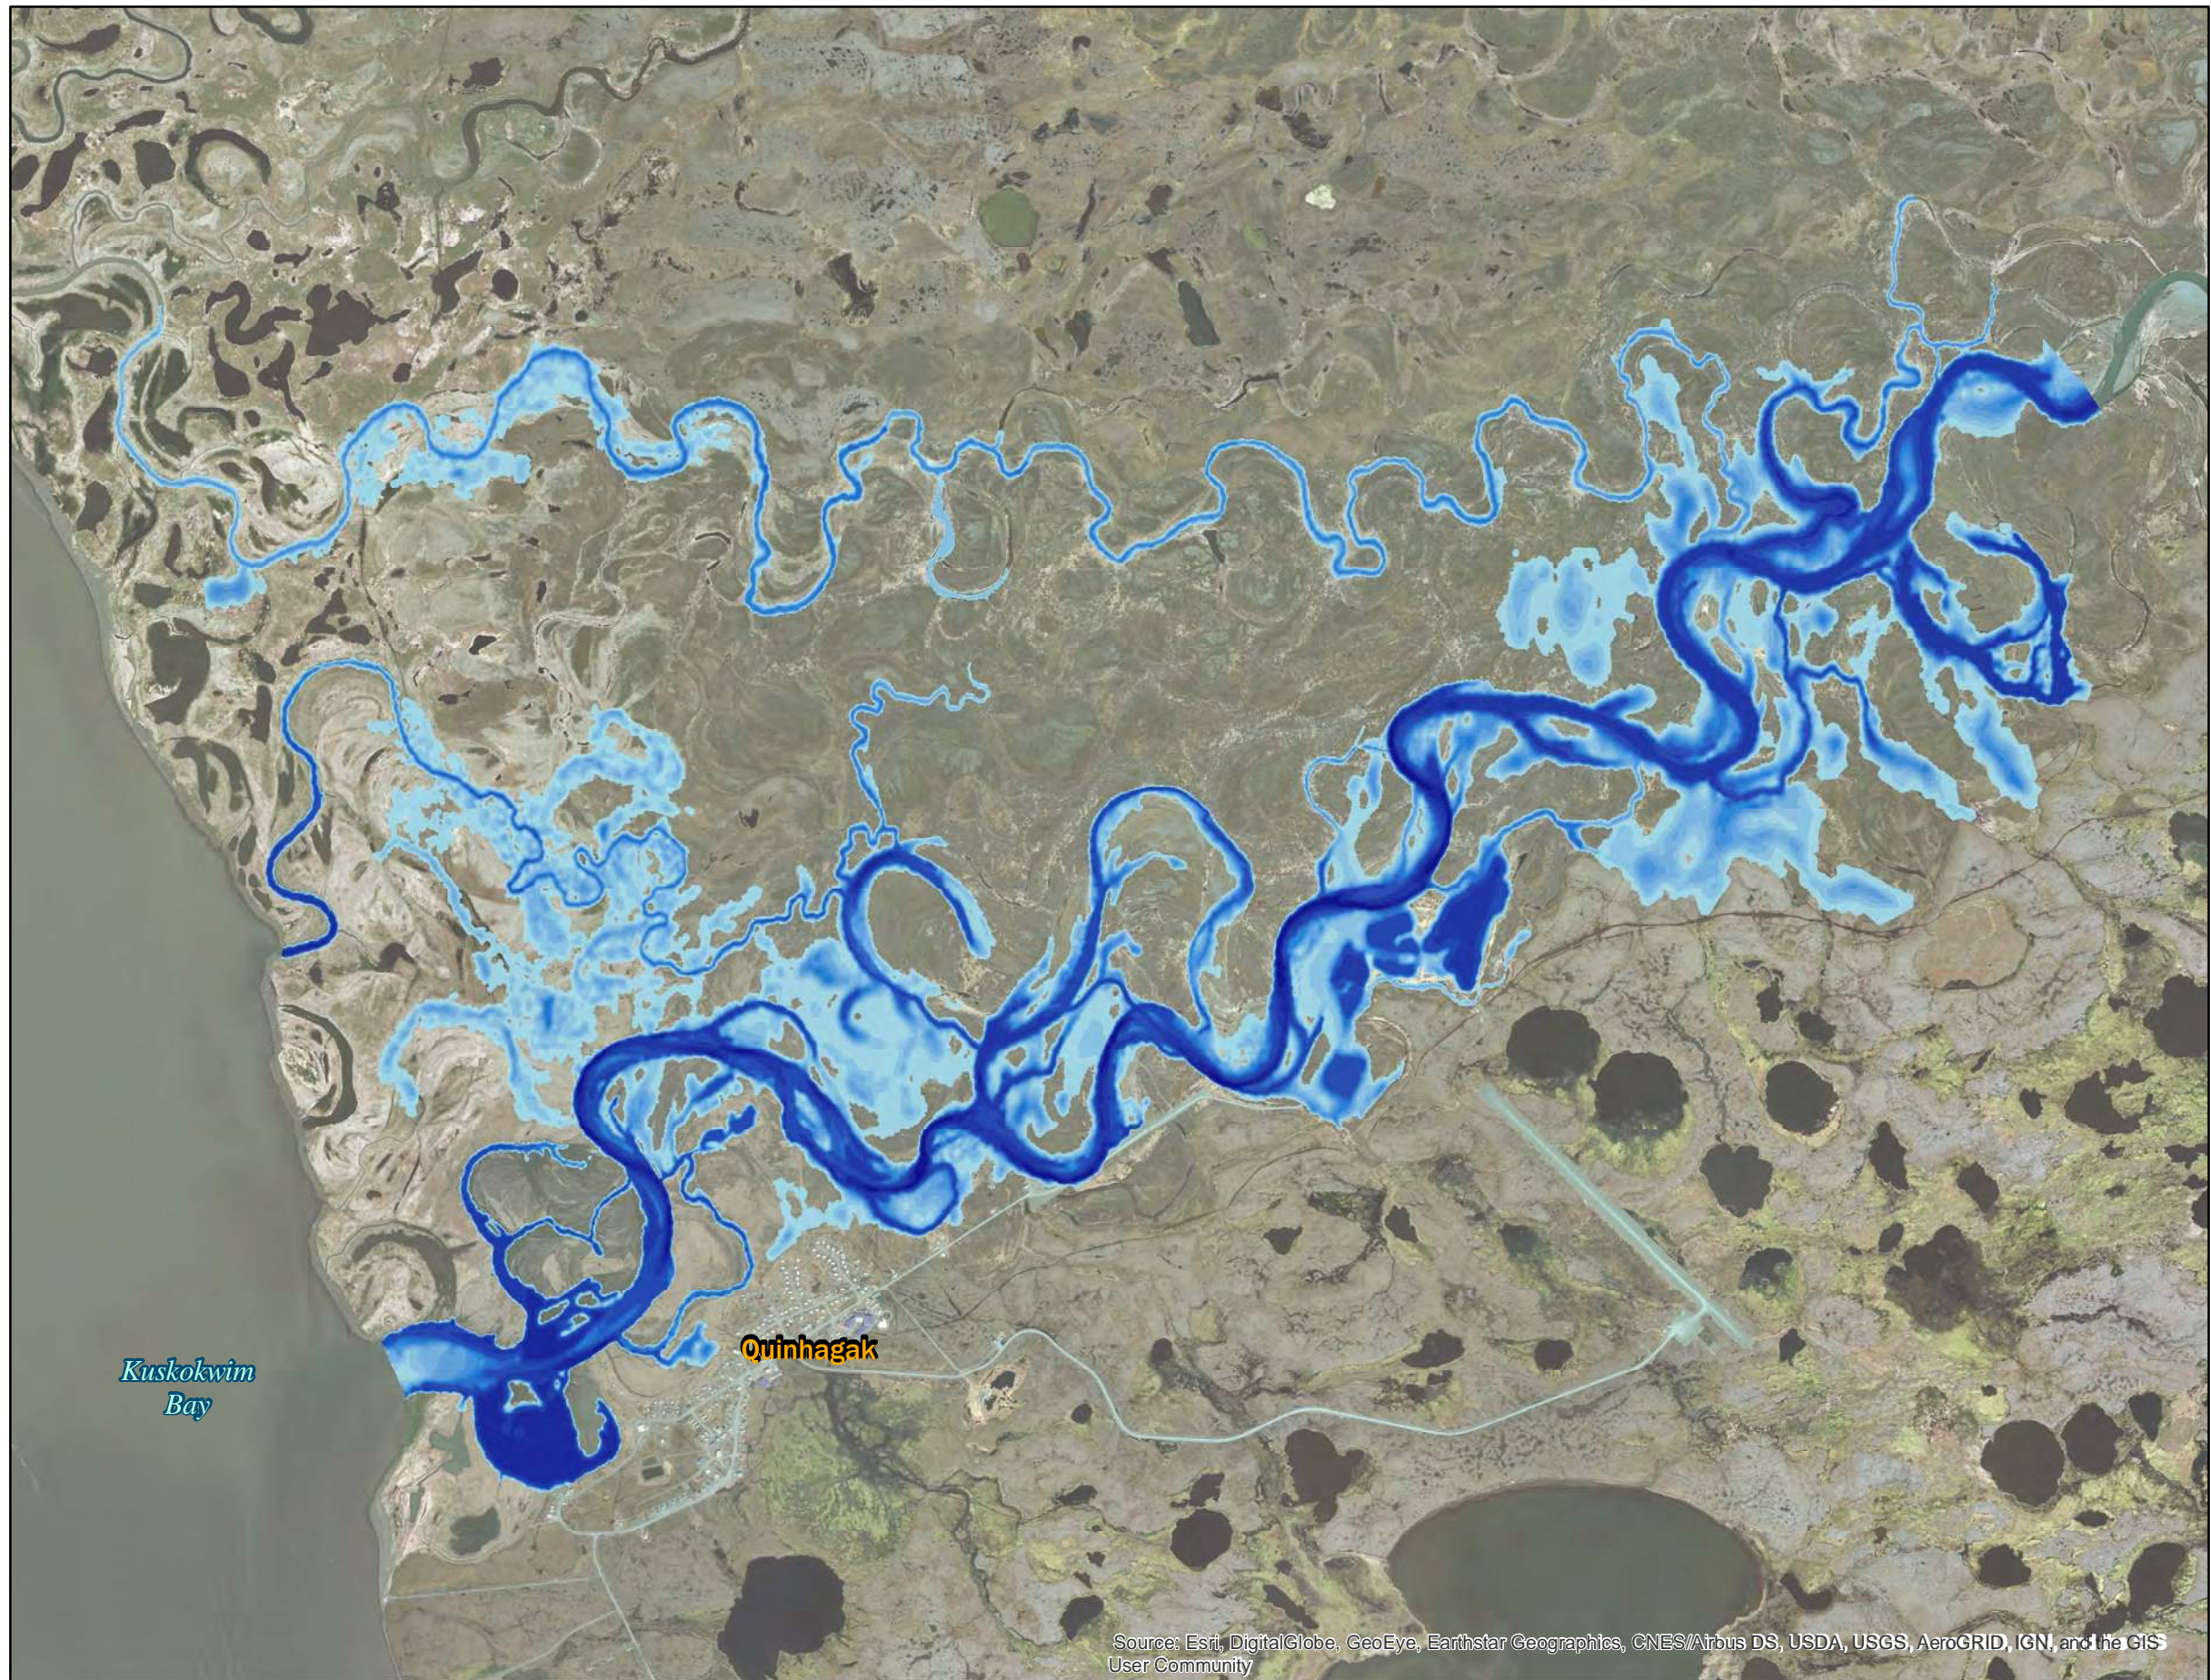
**Figure B-5.**  
**Alternative 3**  
**2 Year Maximum Depth.**

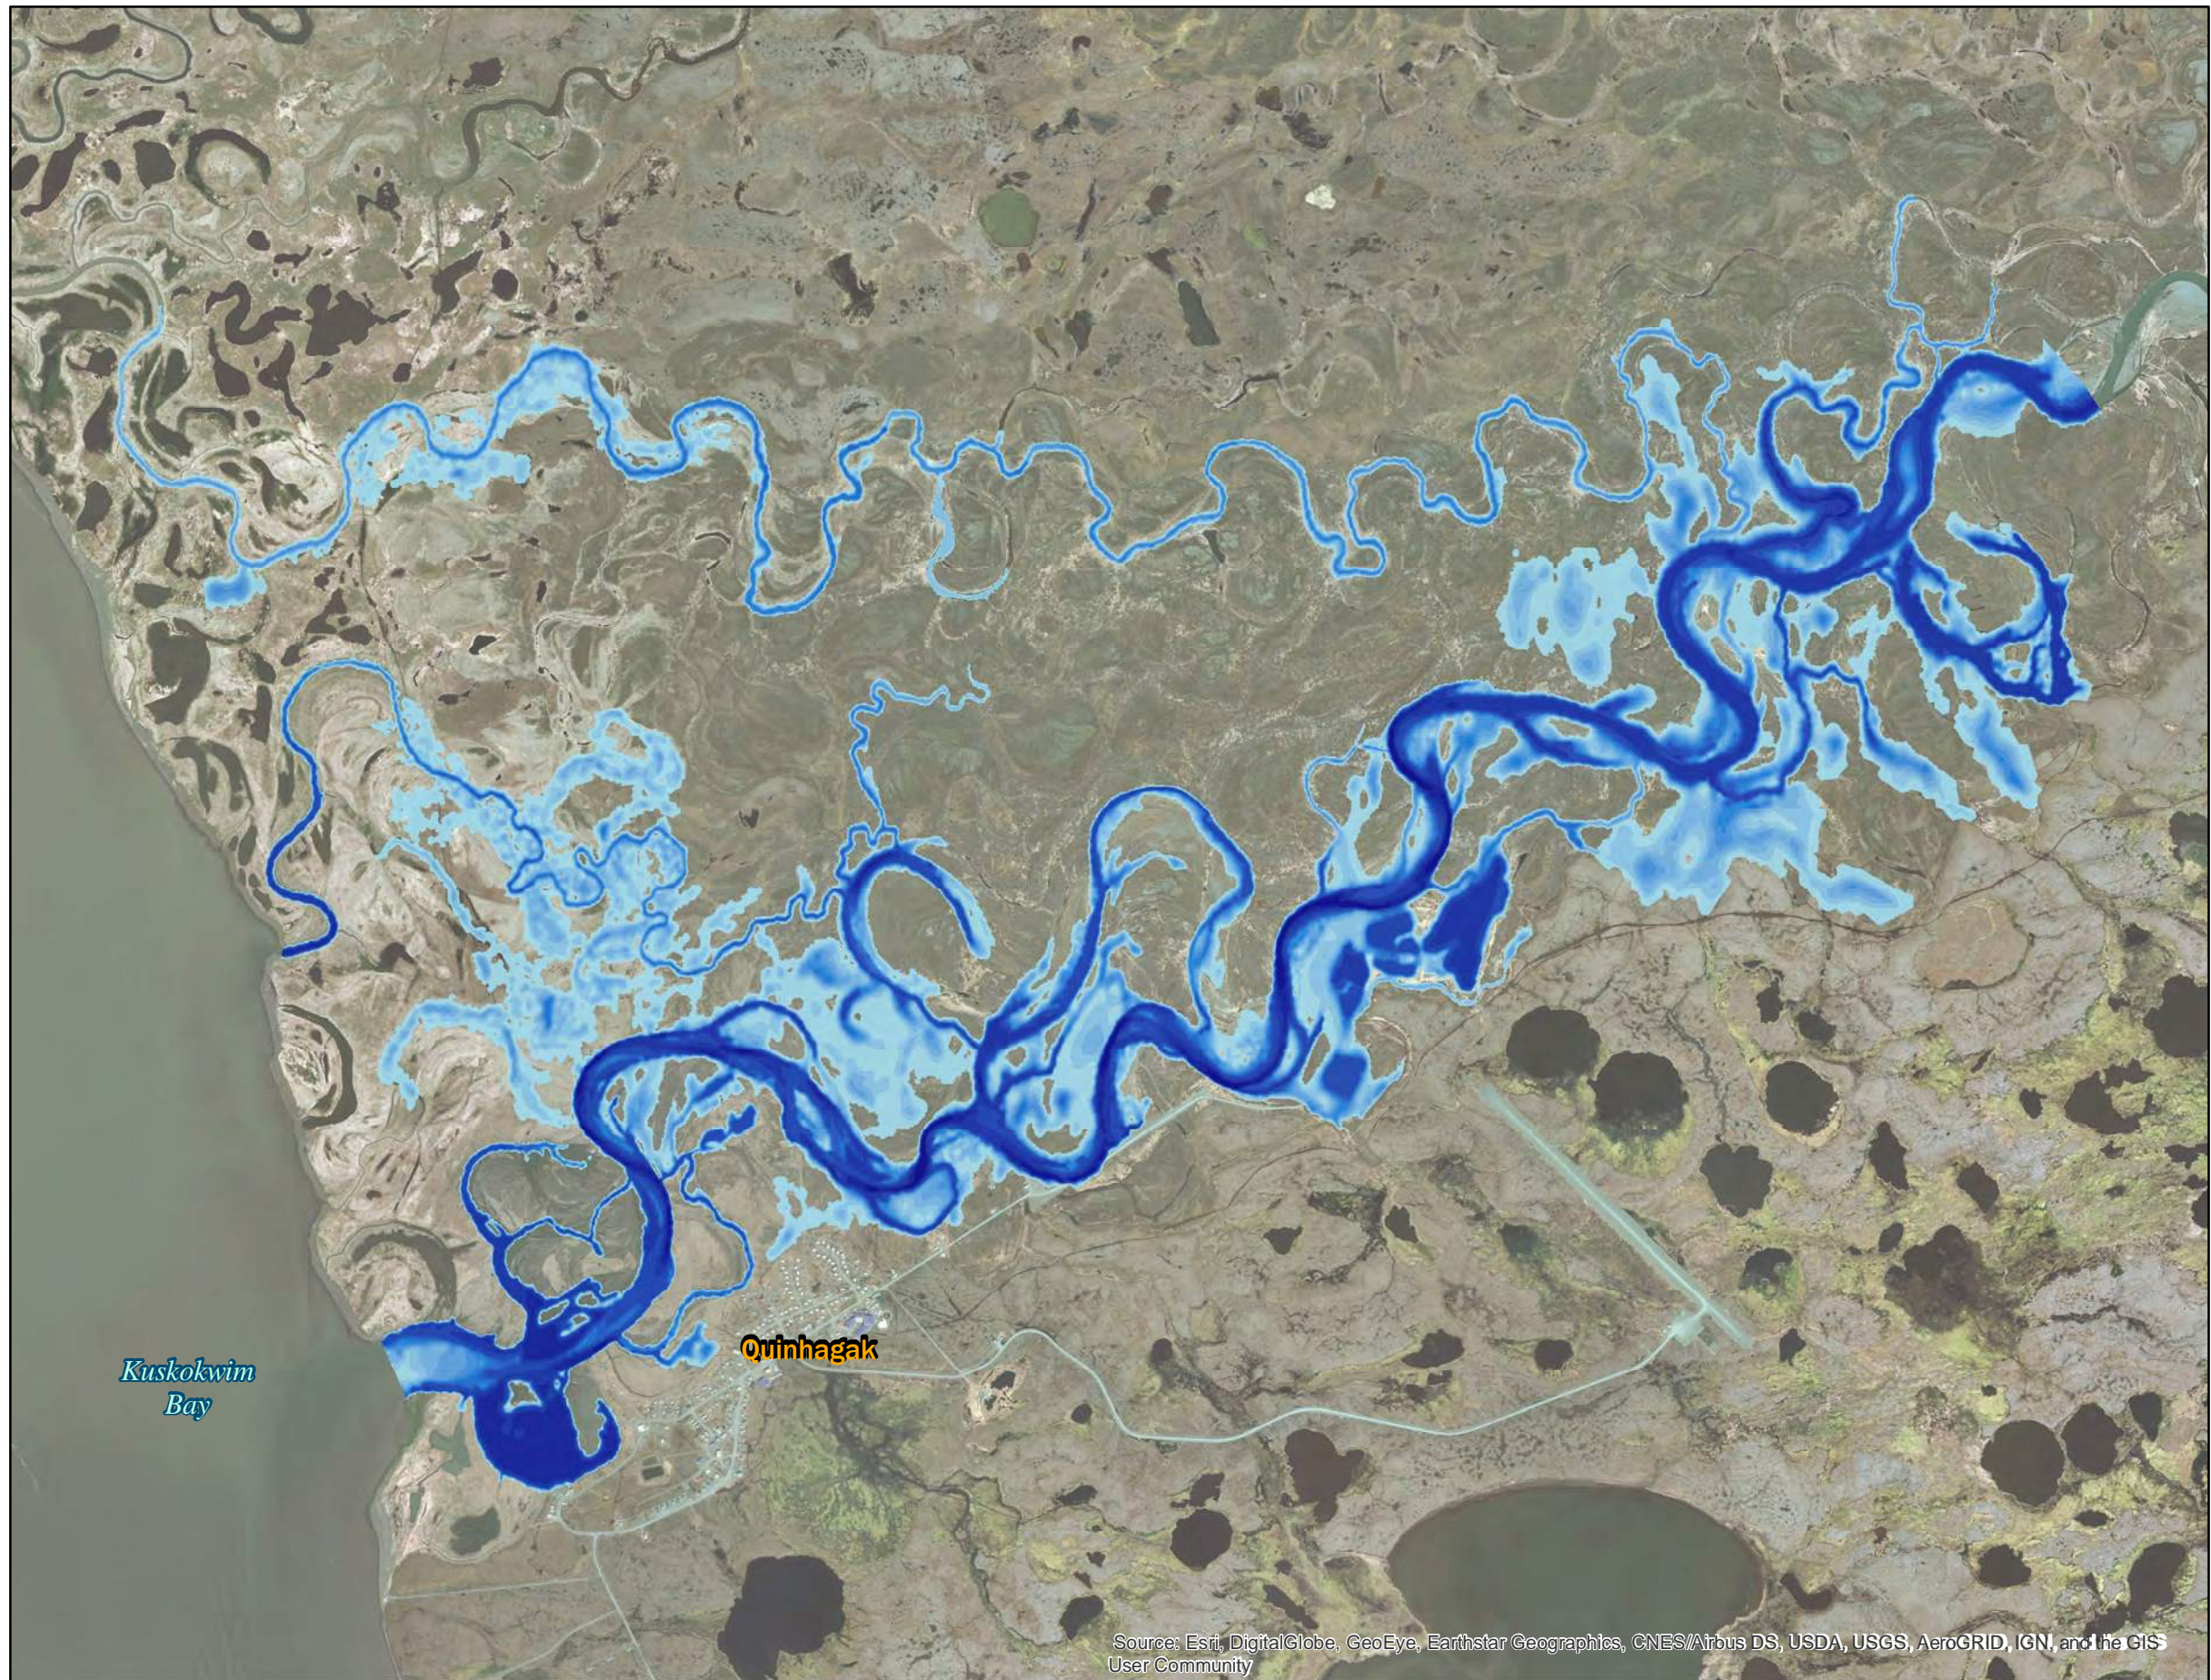
Figure B-7.  
Alternative 4  
2 Year Maximum Depth.

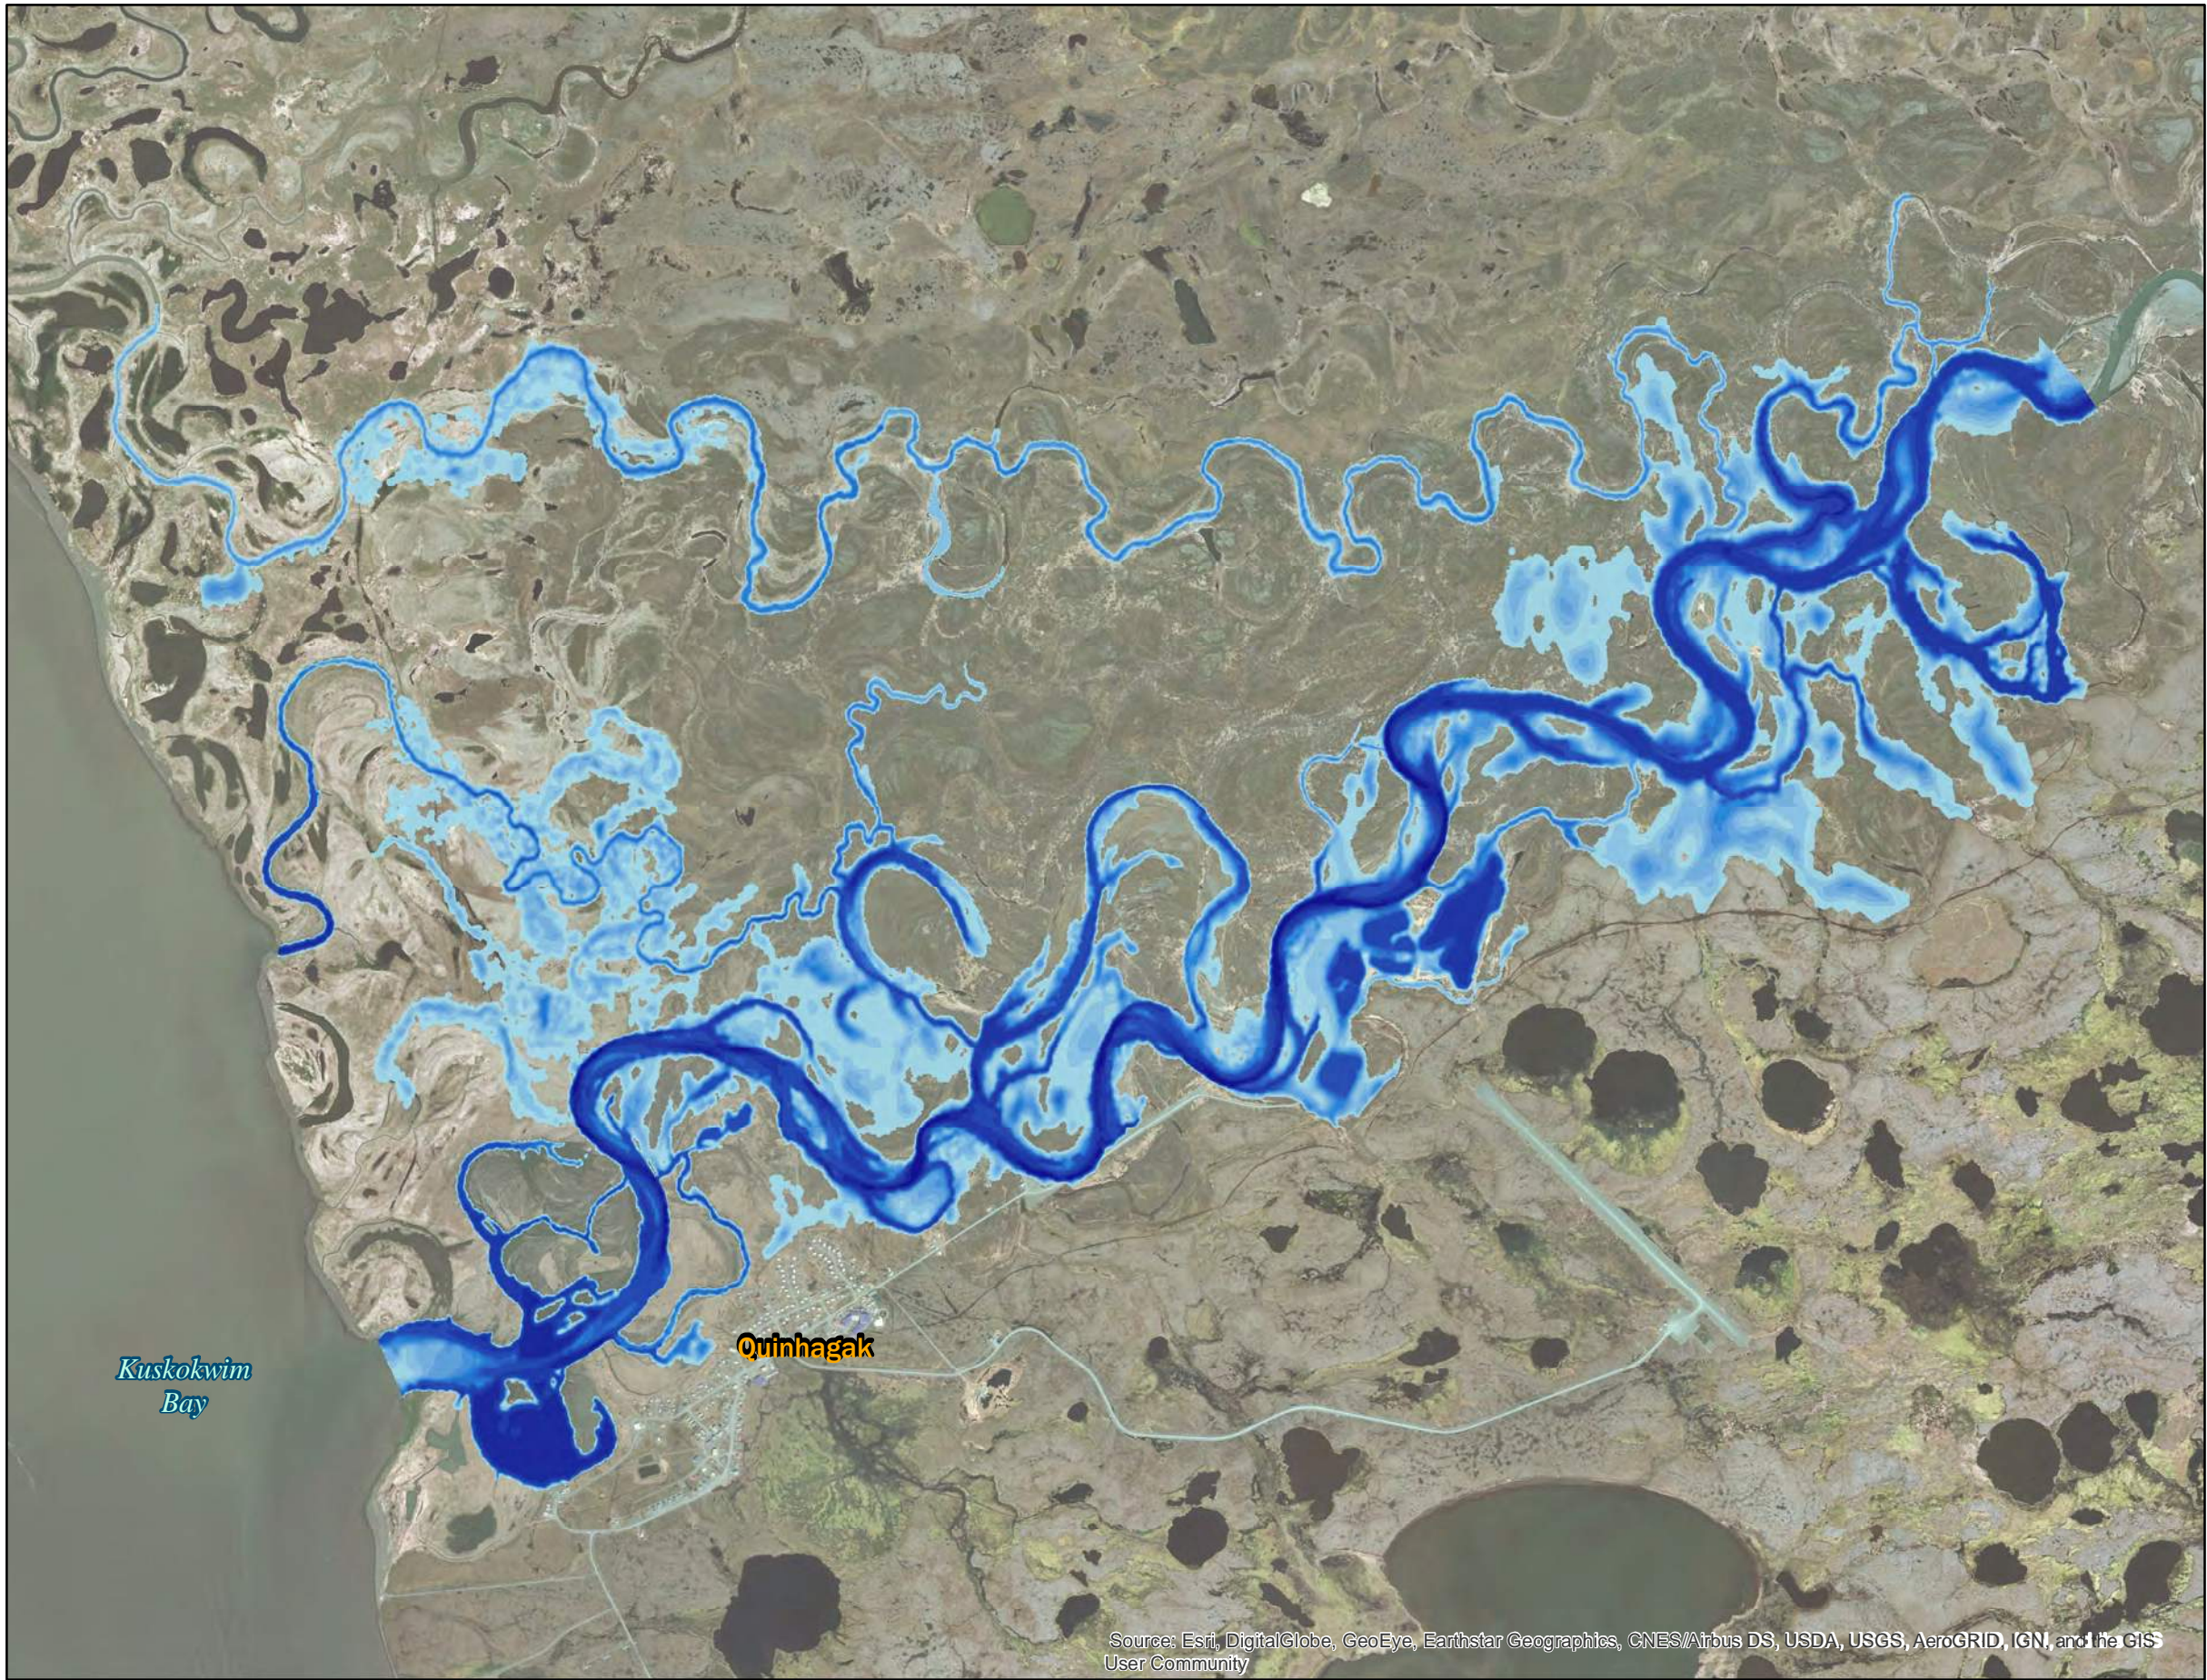
Figure B-9.  
Alternative 5  
2 Year Maximum Depth.
